Troubleshooting

Cellwasher not decanting

Cellwasher 2+ /Centra W
Revision Date: January 6, 15
More text: Here

Decant Problems in Centra W or CW2 Plus Cell Washer

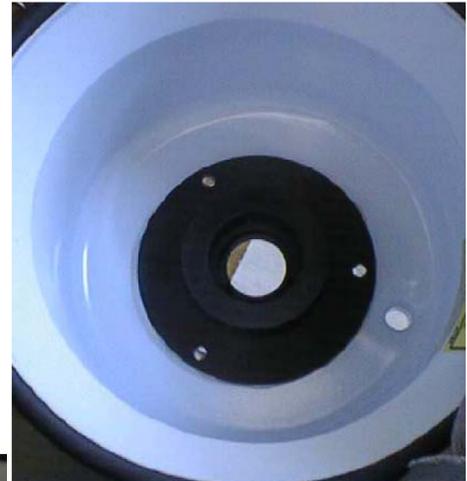
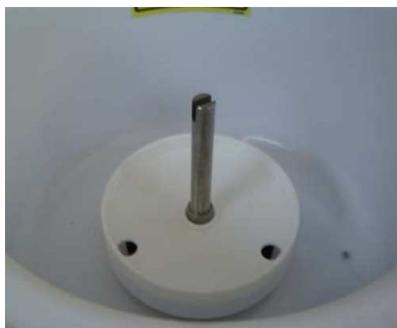
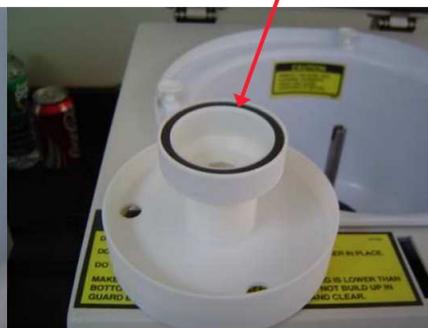
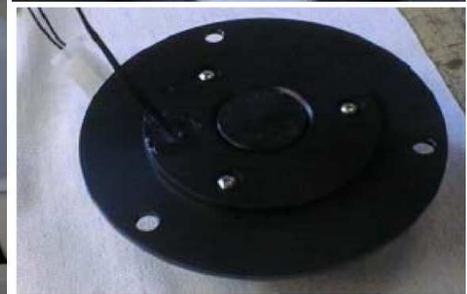
- The decant function of the Centra-W Cell Washer involves three elements. The rotor, solenoid plunger and solenoid coil.

The solenoid plunger (located beneath the rotor) has a metal band on it which, when the solenoid coil is energized, is pushed upward, locking the bottom tabs of the tube holders at a negative angle. Then, when the rotor is spun at low speed, the saline is forced up the sides of the tubes and out.

There are several factors which can prevent proper decanting.

1. Saline build up in the solenoid plunger well and/or on the motor shaft
2. Corroded or dirty solenoid plunger.
3. Broken tube holder tabs on rotor.
4. Defective solenoid coil.
5. PC board.

The #1 cause of Decant problems is cleanliness

If there are any signs of salt build-up on the rotor and or plunger, soak in warm water and a mild detergent (paying particular attention to the inside of the plunger and the metal band). Rinse thoroughly under warm water. Take a damp cloth and wipe any saline residue from the well that the plunger sits in.

If there are any signs of salt build-up on the motor shaft, clean it with warm water and a mild detergent. If the shaft is corroded or rusted, stuff the plunger well with a cloth, use steel wool or an Emory cloth to clean the shaft smooth and coat with a thin layer of petroleum jelly.

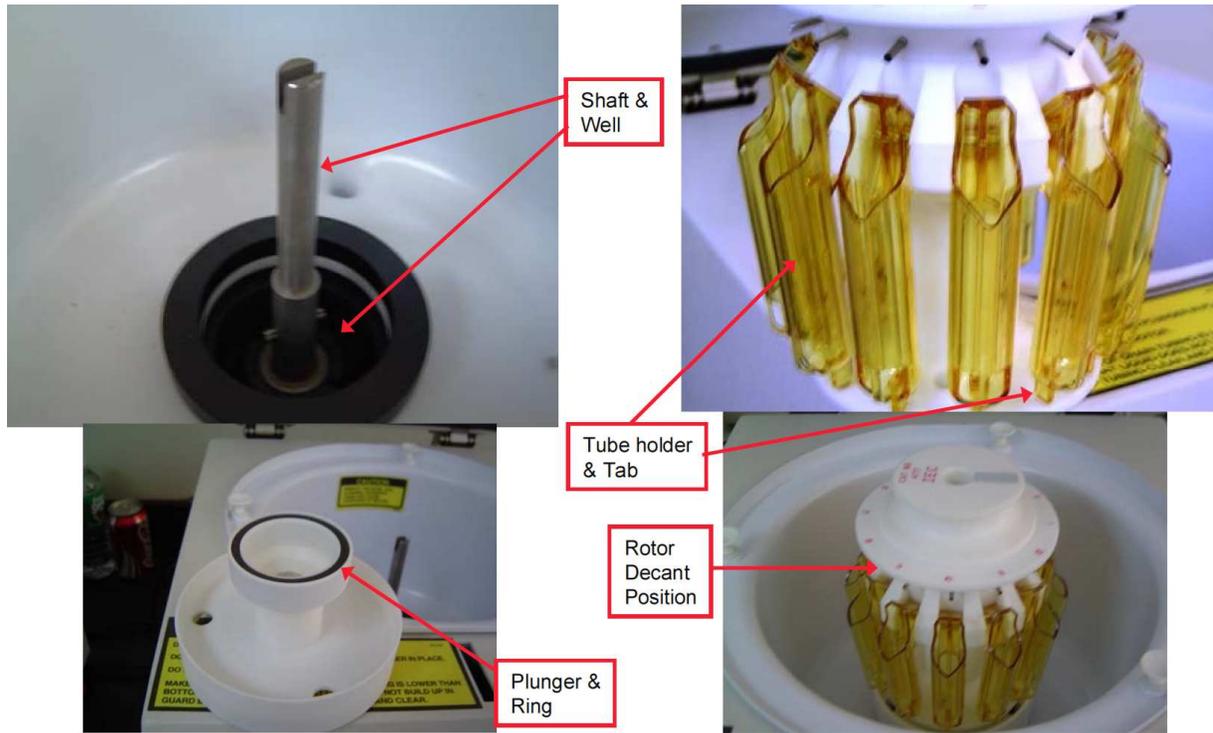
To verify the Decant coil and PCB, use the following procedure:

1. Remove the cabinet.
2. Disconnect the solenoid coil at connector J8.
3. Connect DVM between the 2 black leads, coil resistance should be 645 ohms

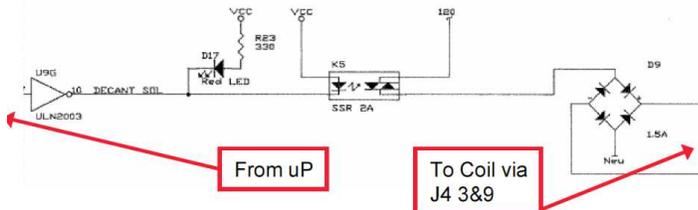
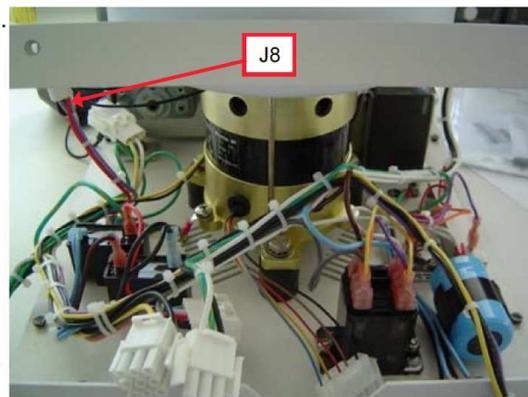
To check power to the Decant coil

1. Re-connect the Latch harness (The harness can be connected by placing the cabinet on its side with the control panel opening towards the base. Feed the harness through the control panel opening to reach the latch assembly for connection.)
2. Place probes in the back of the J8 connector shell.
3. Power up, select 1 Wash cycle
4. At Decant (3rd step) voltage to the coil should be appx 140 VDC (SOL LED on). If voltage present check coil resistance and cleanliness, if voltage not present, replace the PCB.

DEC: This red LED Indicates the decant coil circuit is activated.
